**REPORT NO. 01-16**

**M871A3 TACTICAL TRAILER**  
**22.5-TON PAYLOAD CAPACITY**  
**TP-94-01,**  
**“TRANSPORTABILITY TESTING PROCEDURES”**

**M871 Tactical Trailer, 22.5-Ton Payload Capacity  
TP-94-01, "Transportability Testing Procedures"**

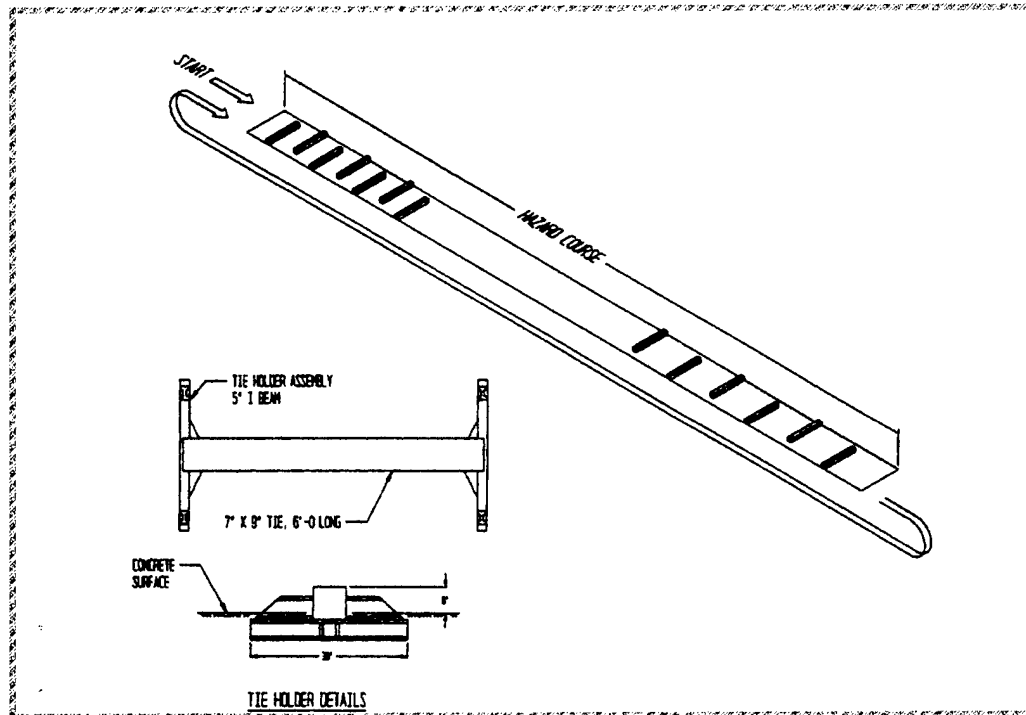
**Figure 2. Hazard Course Sketch**

**B. HAZARD COURSE.** The loaded M871A3 trailer was transported over the 200-foot-long segment of concrete-paved road consisting of two series of railroad ties projecting 6 inches above the level of the road surface. The hazard course was traversed two times (see Figure 2).

1. The first series of ties are spaced on 10-foot centers and alternately positioned on opposite sides of the road centerline for a distance of 50 feet.
  2. Following the first series of ties, a paved roadway of 75 feet separates the first and second series of railroad ties.
  3. The second series of ties are spaced on 8-foot centers and alternately positioned on opposite sides of the road centerline for a distance of 50 feet.
- The test load is driven across the hazard course at speeds that would produce the most violent vertical and side-to-side rolling reaction obtainable in traversing the hazard course (approximately 5 mph).

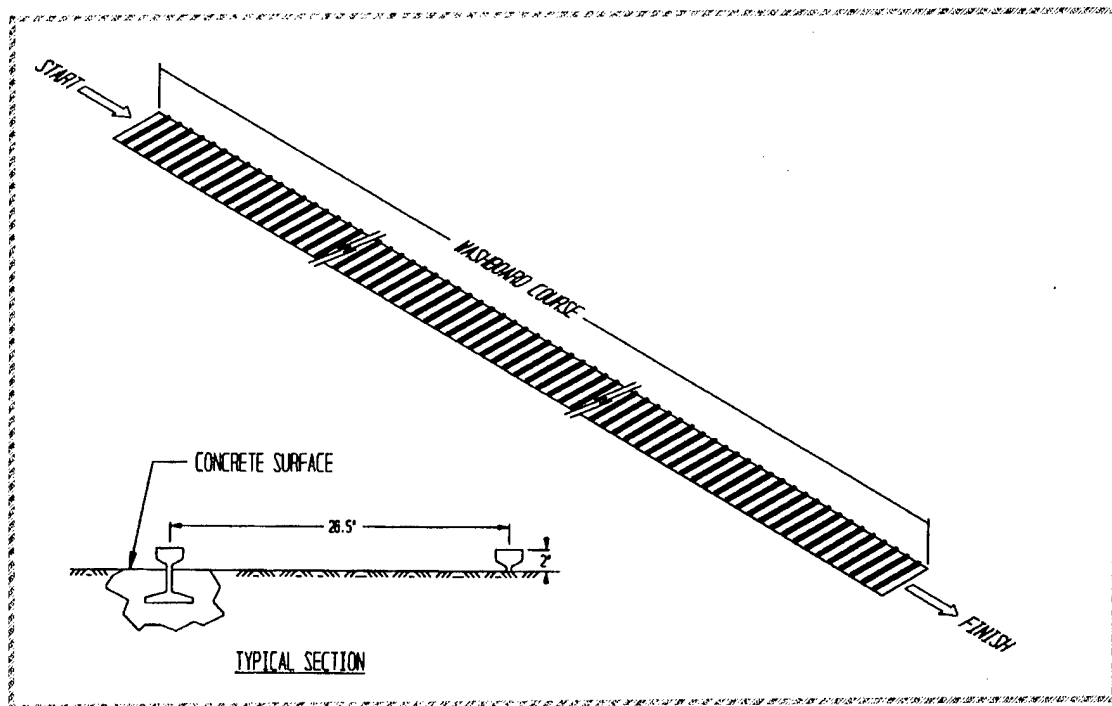
Figure 3. Washboard Course Sketch

E. **WASHBOARD COURSE.** The loaded M871A3 trailer was driven over the washboard course at a speed that produced the most violent response in the vehicles.

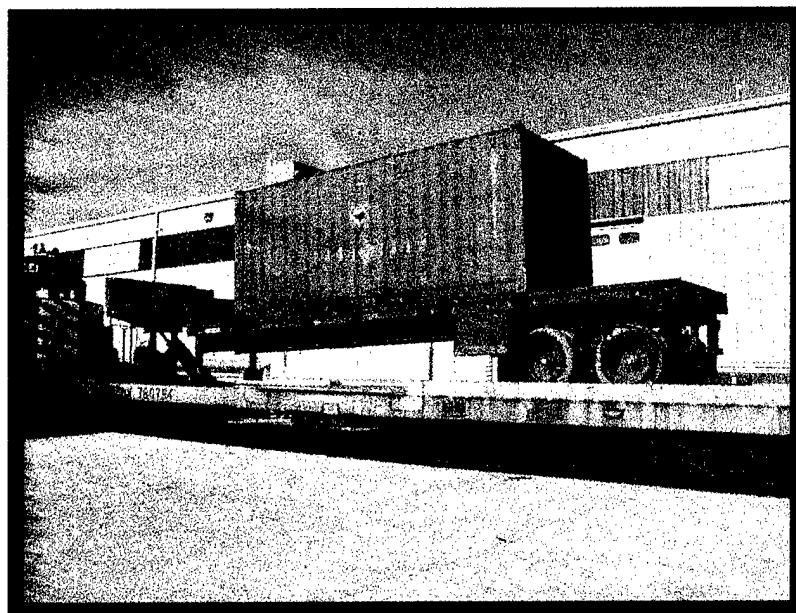
**Photo 1: Trailer-on-Flatcar Rail Impact Testing of M871A3 Trailer**

1. No damage or excessive movement occurred with the trailer, container or twistlocks during testing.
2. The test times for impacts 1-3 were obtained using a stopwatch. For impact 4 an electronic speed sensor was used.
3. Impacts 1-3 were conducted with the rear of the trailer in the direction of impact. Impact 4 was with the trailer front in the direction of impact.
4. The trailer was inspected following the removal from the railcar. The kingpin had sustained some galling or flattening damage during the rail impact testing. This was due to the railcar stanchion locking plates had some wear which

prevented secure engagement against the trailer kingpin. The trailer was mission capable and testing continued.

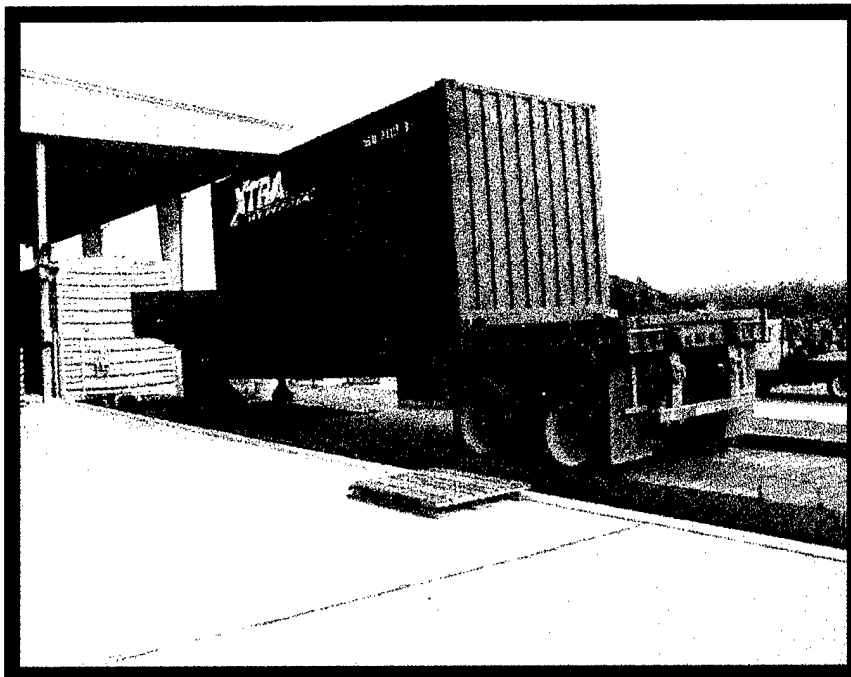
**Photo 4: Trailer-on-Flatcar Rail Impact Testing of M871A3  
Trailer at Full Payload**

1. The brake on the railcar did not fully release on Impact 1. The rail crew corrected the problem and testing continued.
2. Following Impact 4 the twistlock at the door end of the container, driver's side, jammed and would not turn freely. No damage was found on the twistlock or container corner casting. The problem occurred due to the tolerances between the twist lock and the deck opening. This allowed the twistlock to be pushed up and caused it to jam. This did not affect offloading of the container.

3. The reverse 8 mph impact was not performed. Inspection of the area around the stanchion kingpin locking plate revealed a gap of 0.50 to 0.75 inches. This gap was deemed to be excessive and rail impact testing was discontinued until an acceptable flatcar was provided by the rail carrier. The rail impact retest results are shown in "F" of this section.

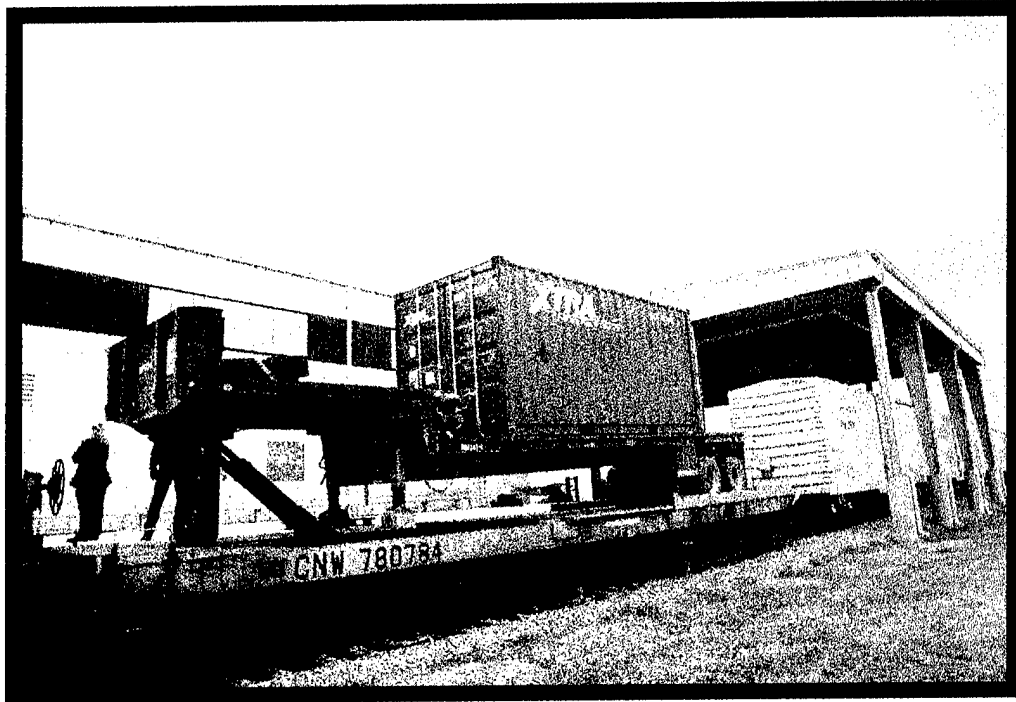
**Photo 5: Trailer on Flatcar Rail Impact Testing of M871A3 Trailer at Full Payload**

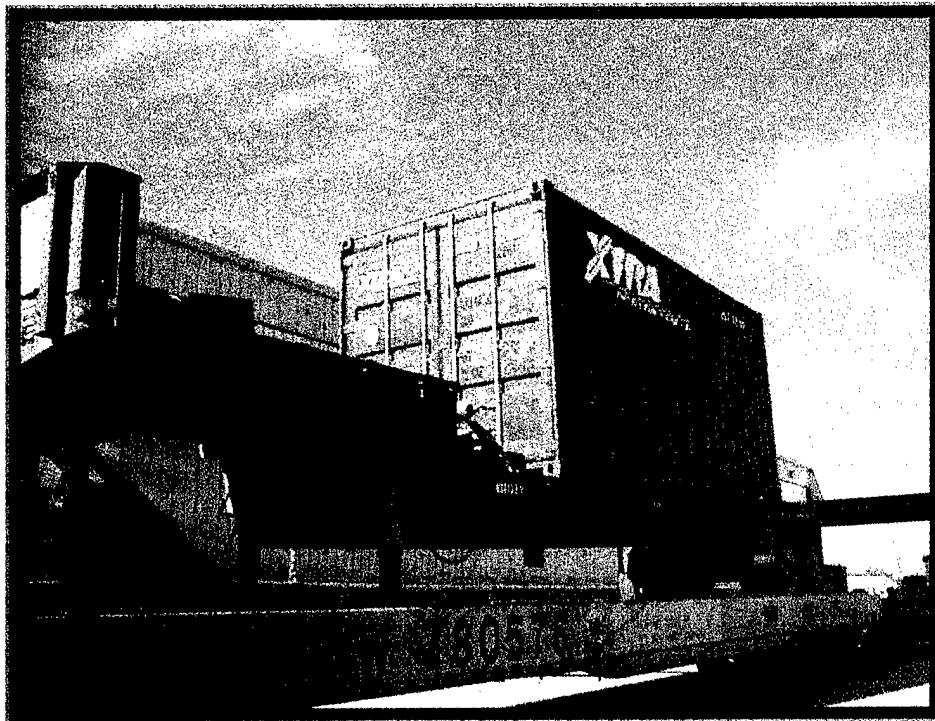
**Photo 6: Trailer-on-Flatcar Rail Impact Testing of M871A3 Trailer at Full Payload**

1. Following Impact 2, the twistlock at the door end of the container, driver's side, jammed and would not turn freely. The reason has been explained previously. This did not affect offloading of the container. The twistlock jammed following the reverse impact.
2. The container moved 0.375 inches following the reverse impact.

3. Impacts 1-4 were conducted with the rear of the trailer facing the direction of impact. Impact No. 1 was low average velocity due to improper brake release on the specimen flatcar. Impact 5 was conducted with the front of the trailer facing the direction of impact.
4. No damage or excessive movement occurred with the trailer, container or twistlocks during testing.
5. The velocity data represents the average speed during the test.

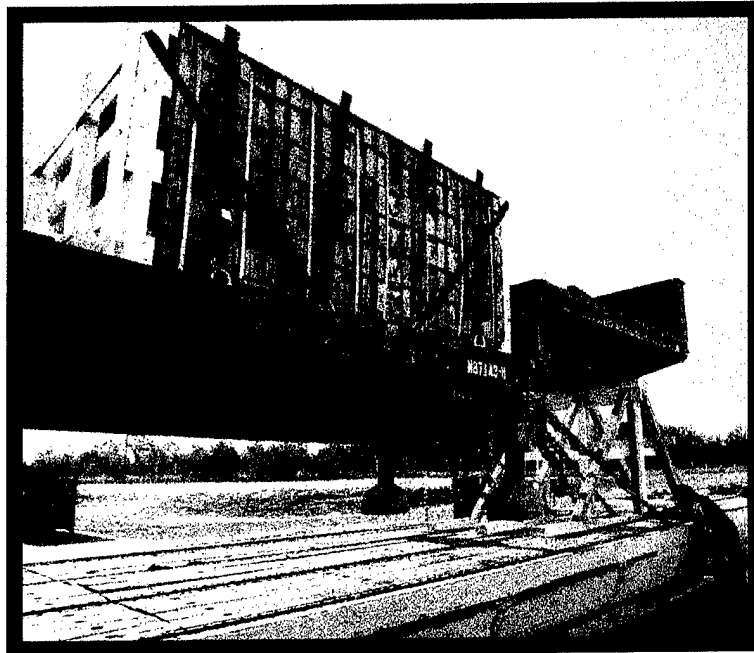
**Photo 7: Breakbulk Load on M871A3 Trailer**

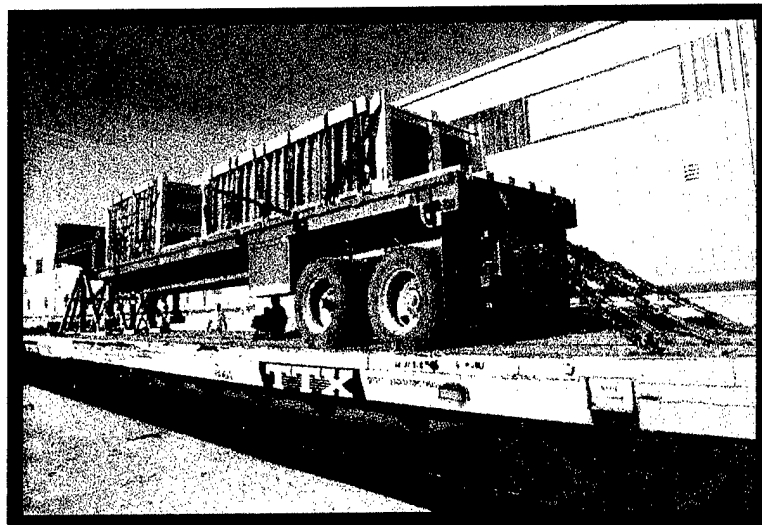
**Photo 8: M871A3 Trailer with Breakbulk Cargo on Flatcar**

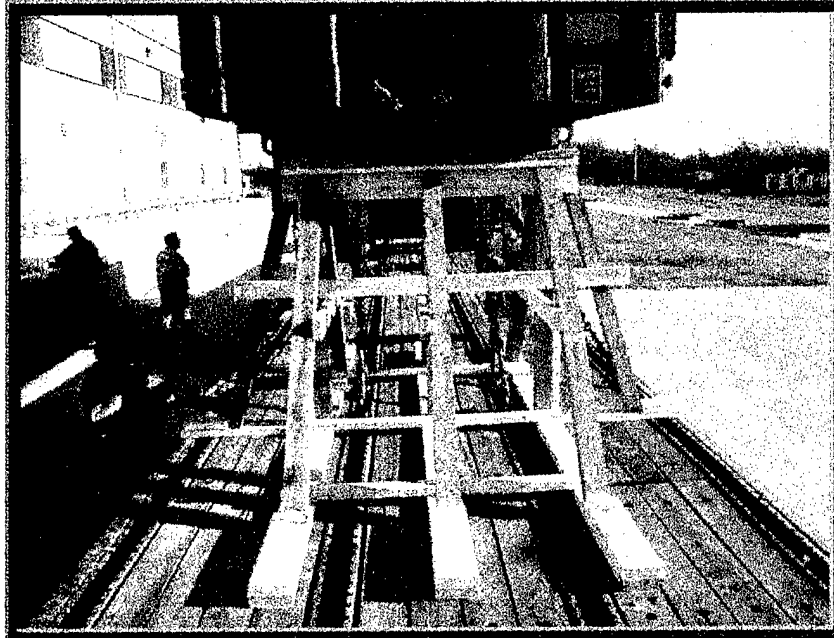
**Photo 9: Wood Stanchion Used During Breakbulk Load Testing**

1. Following Impact 3 there was 0.125 inch of movement between the wood stanchion and the trailer plate.
2. Following Impact 3 the 105MM wood boxes moved 0.375 inch away from the bulkhead.
3. Impacts 1-3 were conducted with the rear of the trailer facing the direction of impact. Impact 4 was conducted with the front of the trailer facing the direction of impact.
4. No damage or excessive movement occurred with the trailer or cargo during testing.
5. The velocity data represents the average speed during the test.

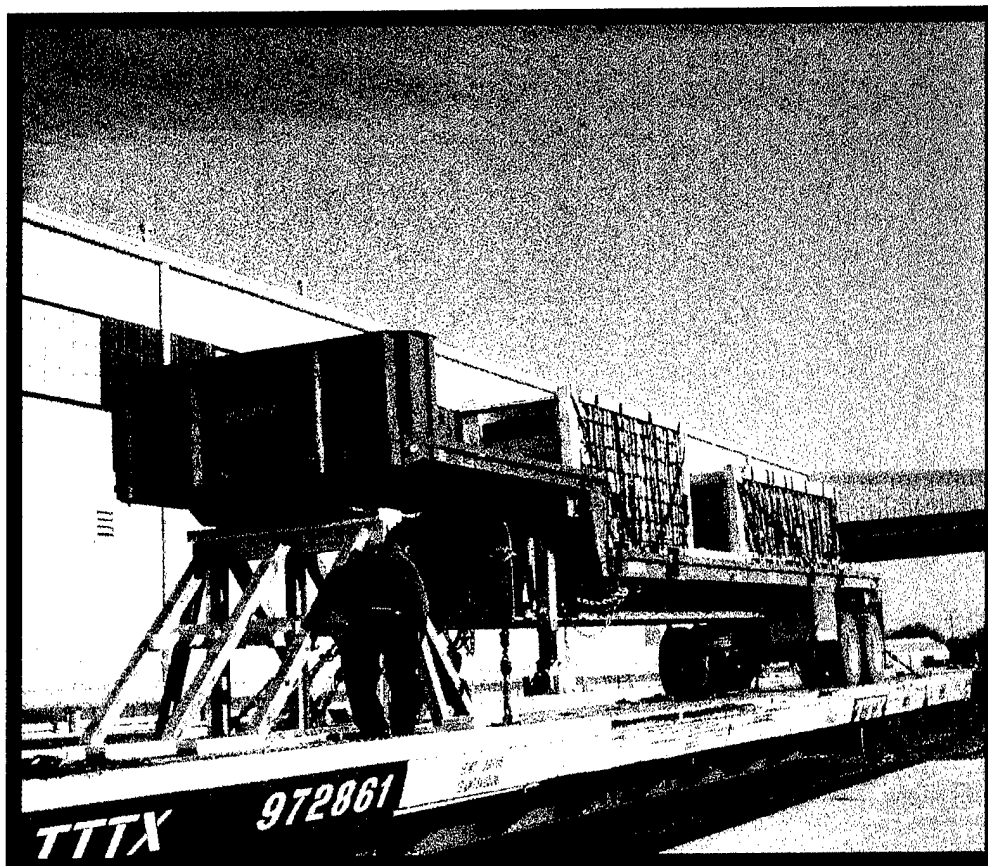
**Photo 10: M871A3 Trailer Loaded with Pallets of 155MM SLPs & 105MM  
Boxed Ammunition**

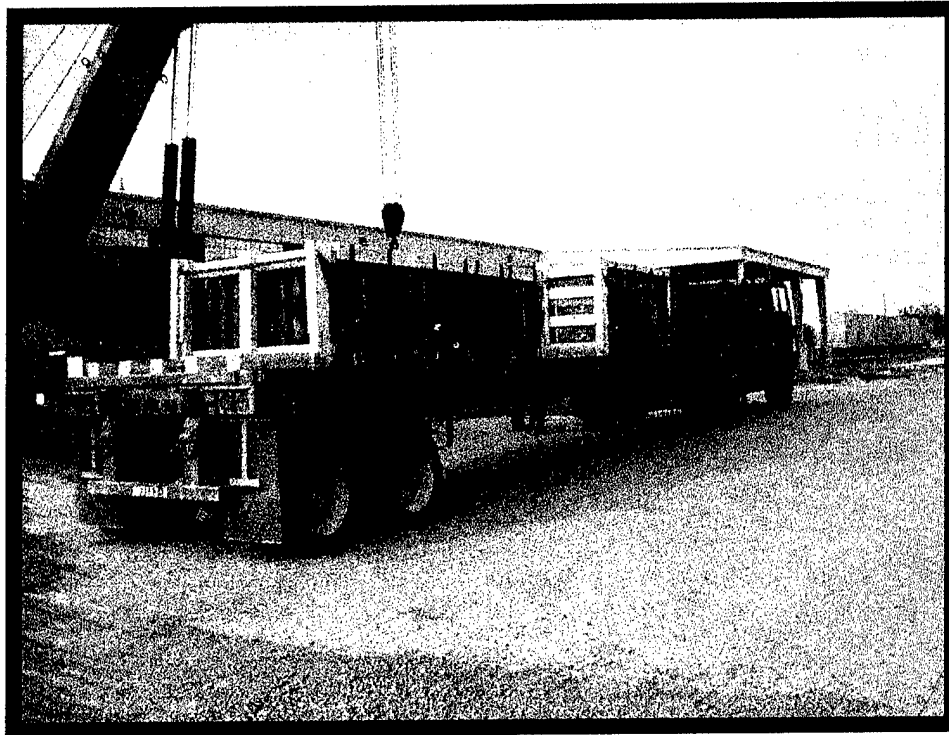
**Photo 11: M871A3 Trailer with Breakbulk Cargo Load**

1. No damage or excessive movement occurred with the trailer or cargo tie-down rings during testing.
2. Following Pass No. 2, the strapping board broke and the end gate started to collapse. The load straps were tightened. This failure was not a result of the trailer design, and therefore, testing was continued.

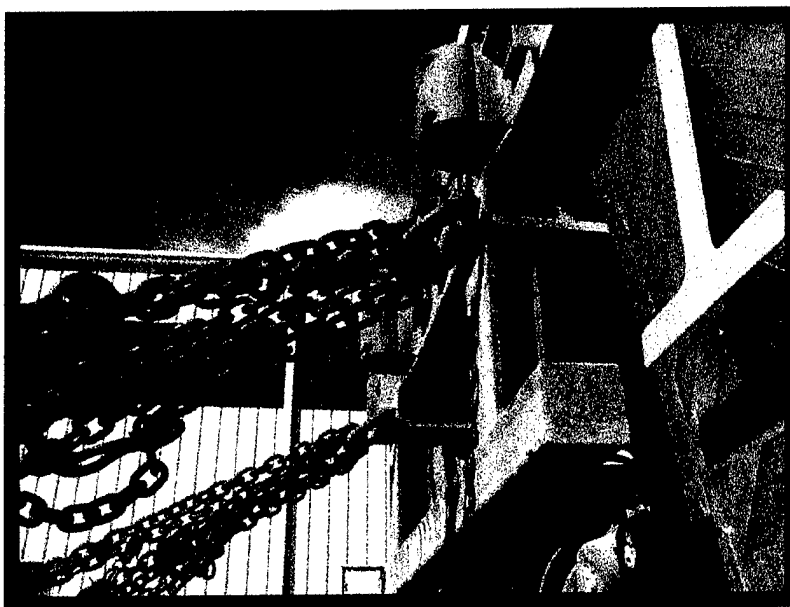
**Photo 12: Rear Chain Tie-down Configuration of the M871A3  
with Full Payload**

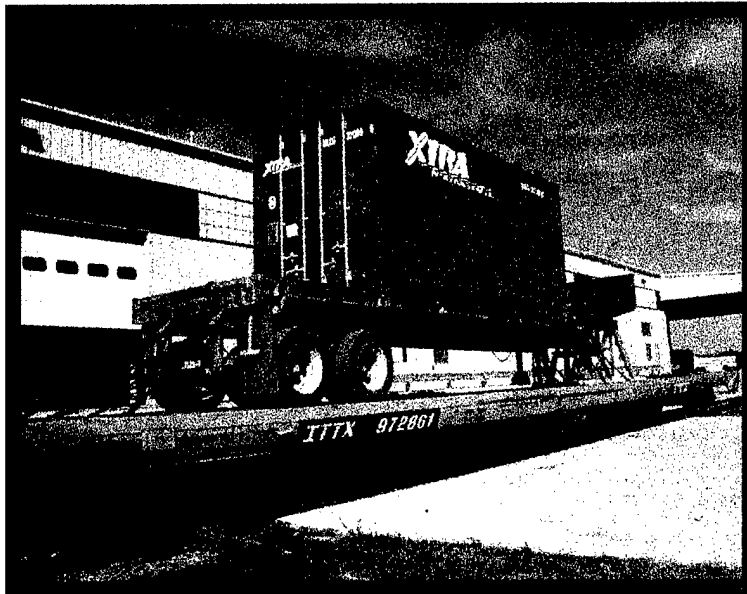
**Photo 13: M871A3 Trailer Testing with Full Payload Chained to the Flatcar**

1. No damage or excessive movement occurred with the trailer, tiedown rings, or twistlocks during testing. Chains remained tight throughout testing.

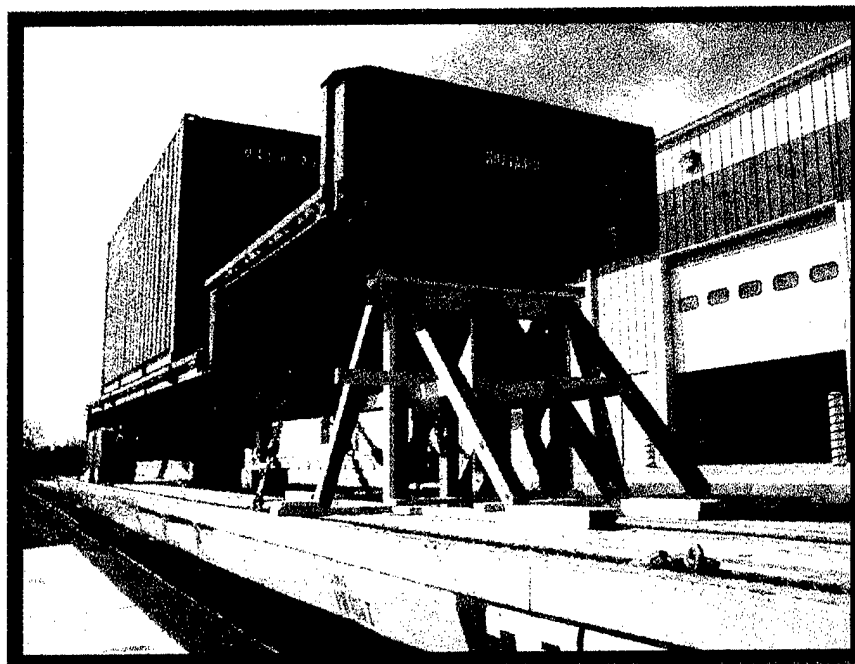
**Photo 14: Wood Stanchion for Full Payload Testing**

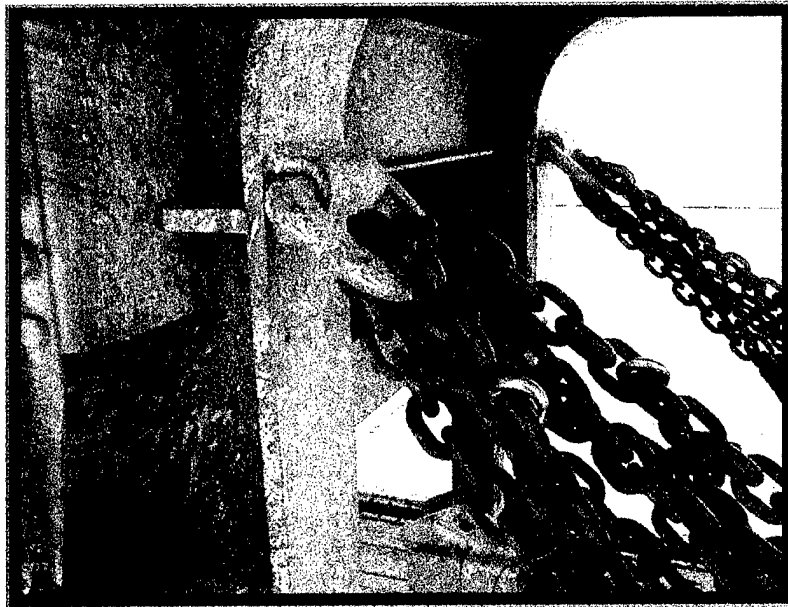
**Photo 15:** Chain tiedown configuration on forward end of the M871A3

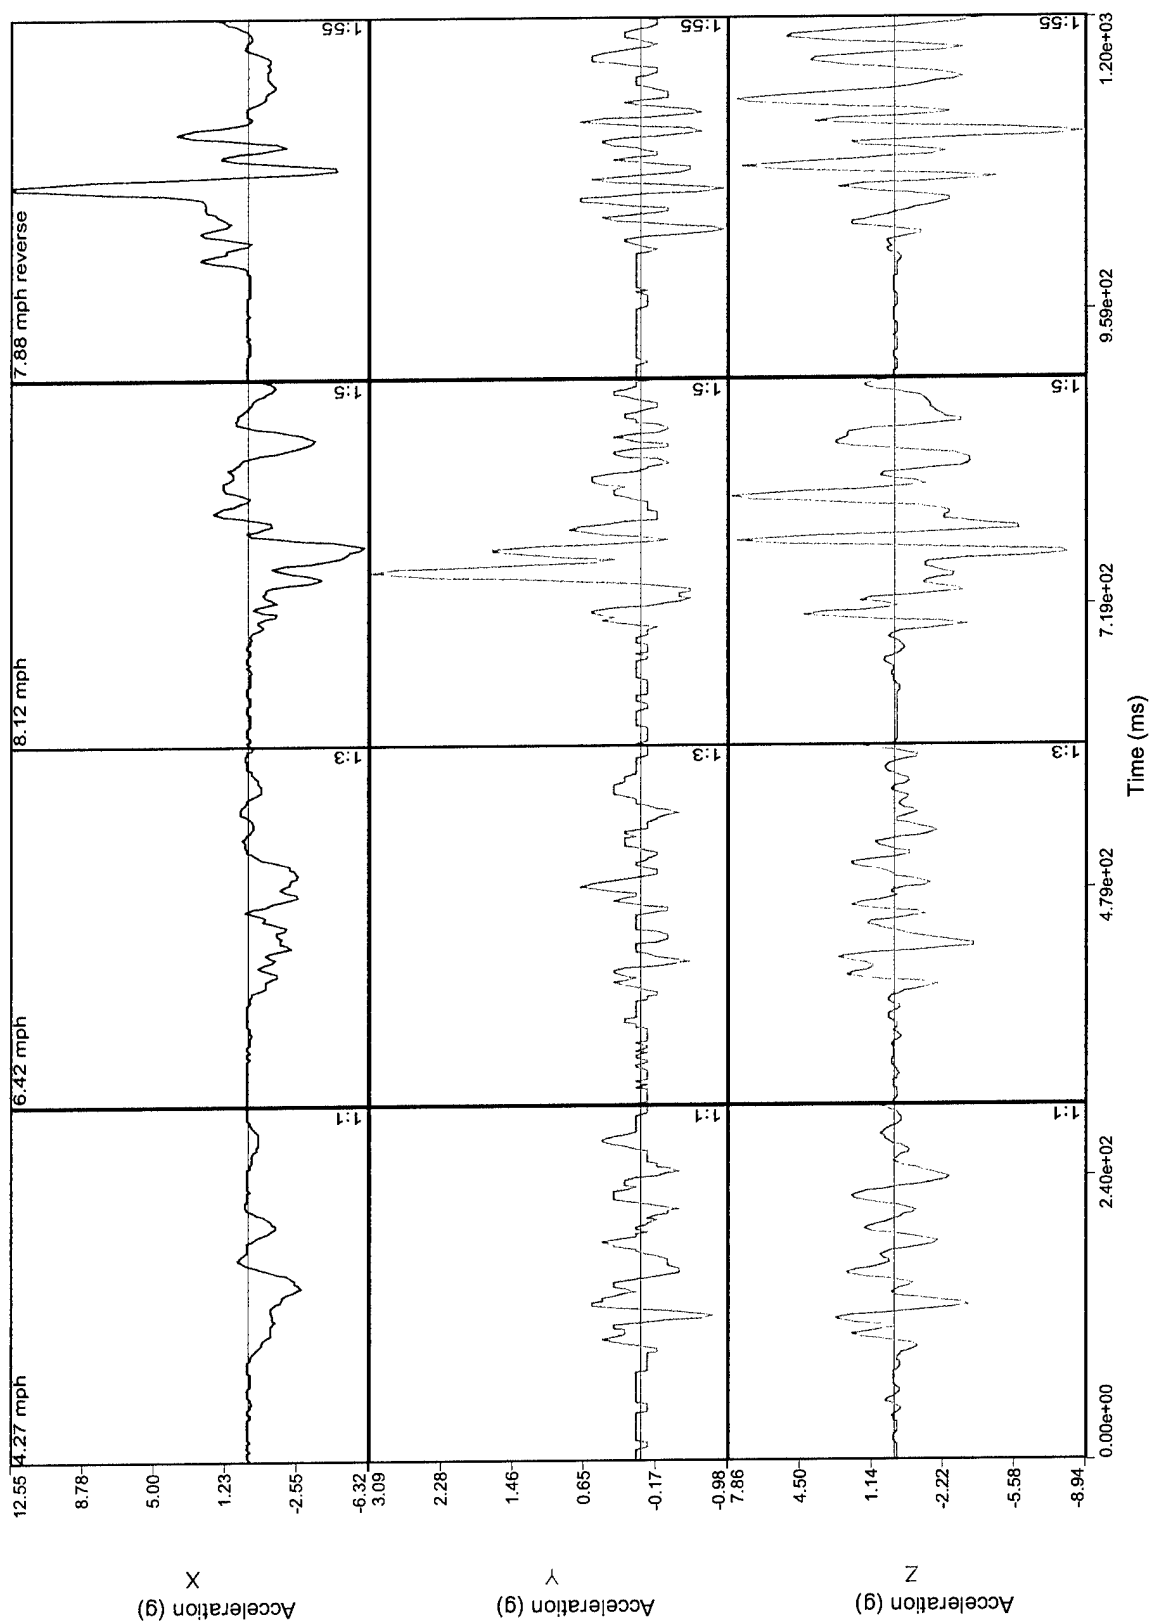
# Rail Impact of M871A3 Trailer with 11,859-lb. Payload Sensor Location: Rear Railcar

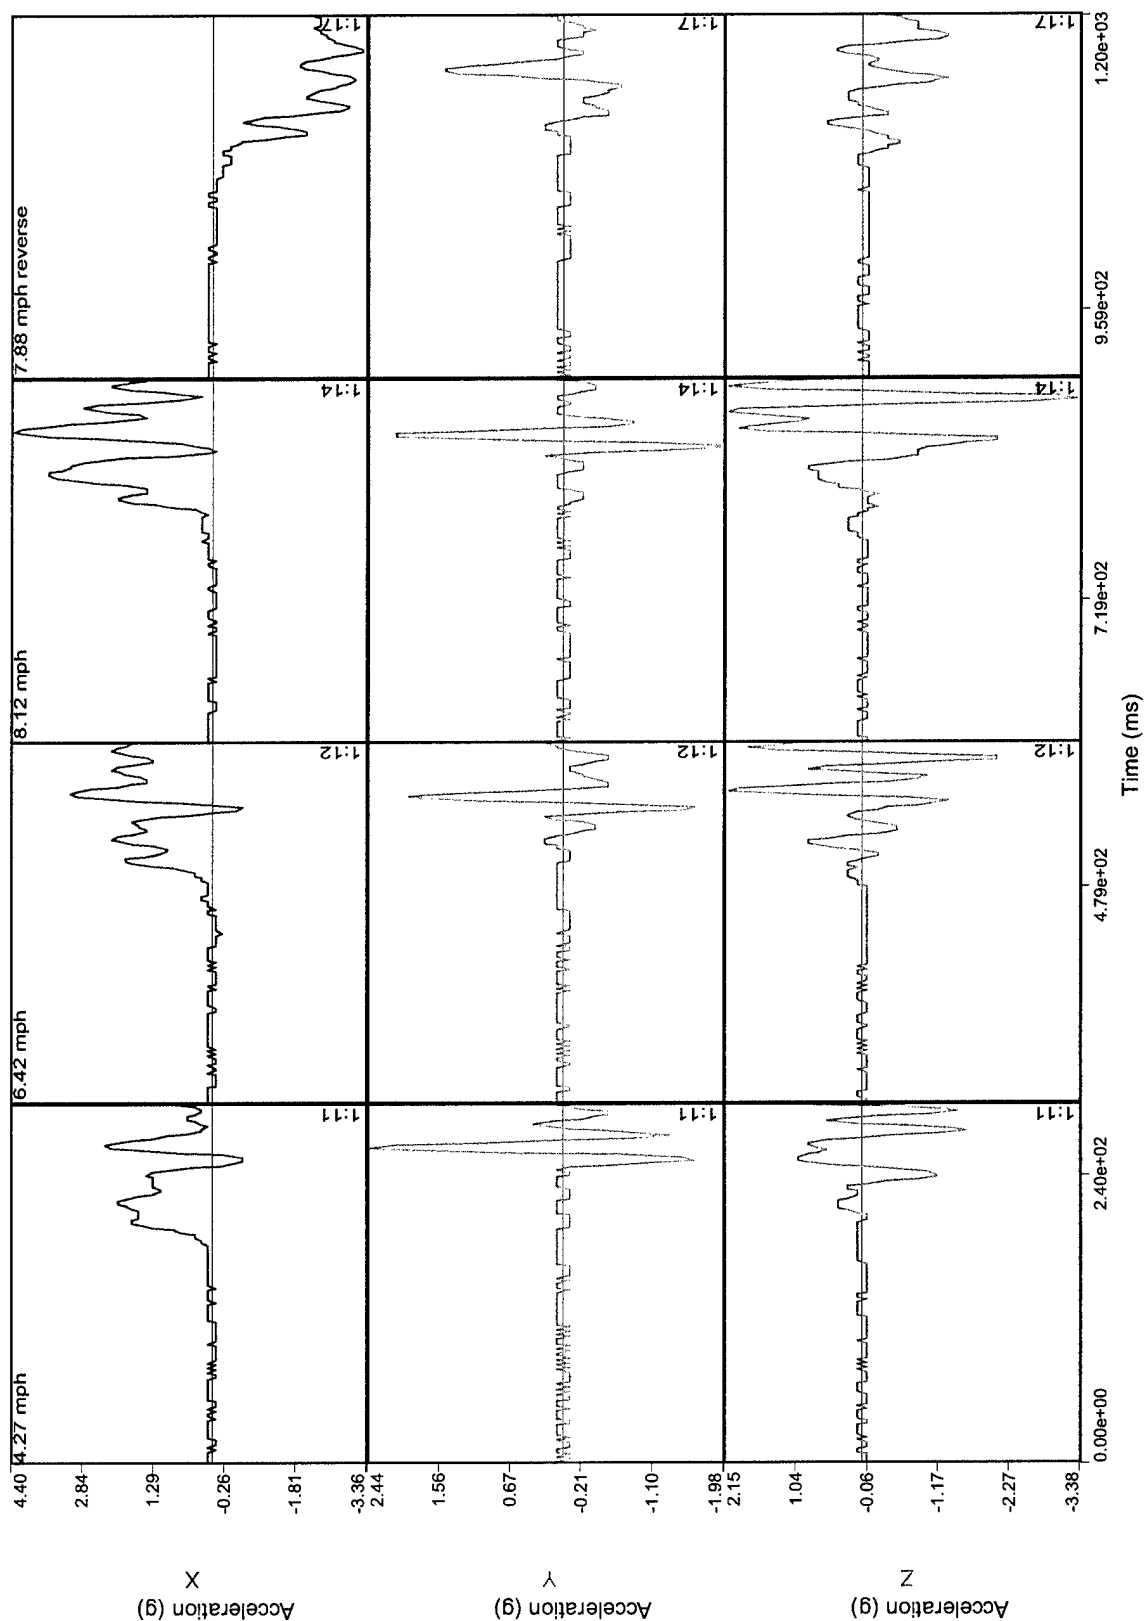
# Rail Impact of M871A3 Trailer with 11,859-lb. Payload Sensor Location: Trailer Rear

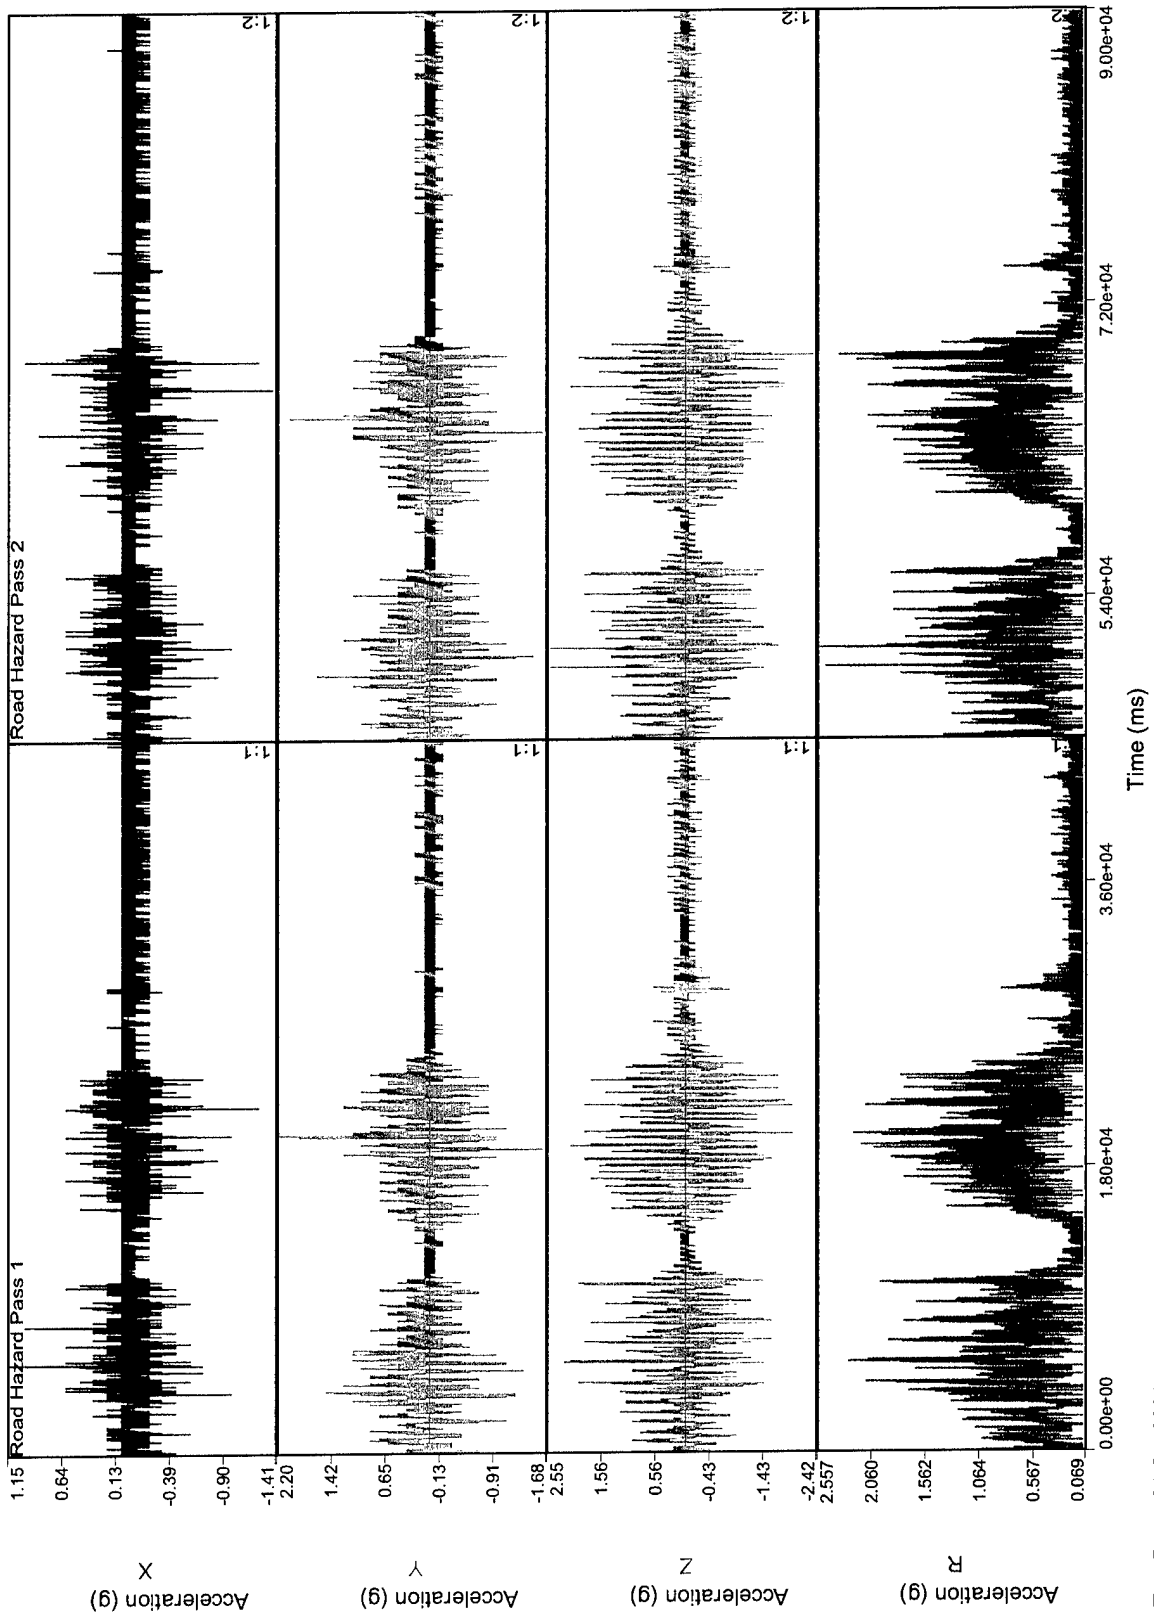
Hazard of M871A3 Trailer with 11,859-lb. Payload      Sensor Location: Trailer Bulkhead

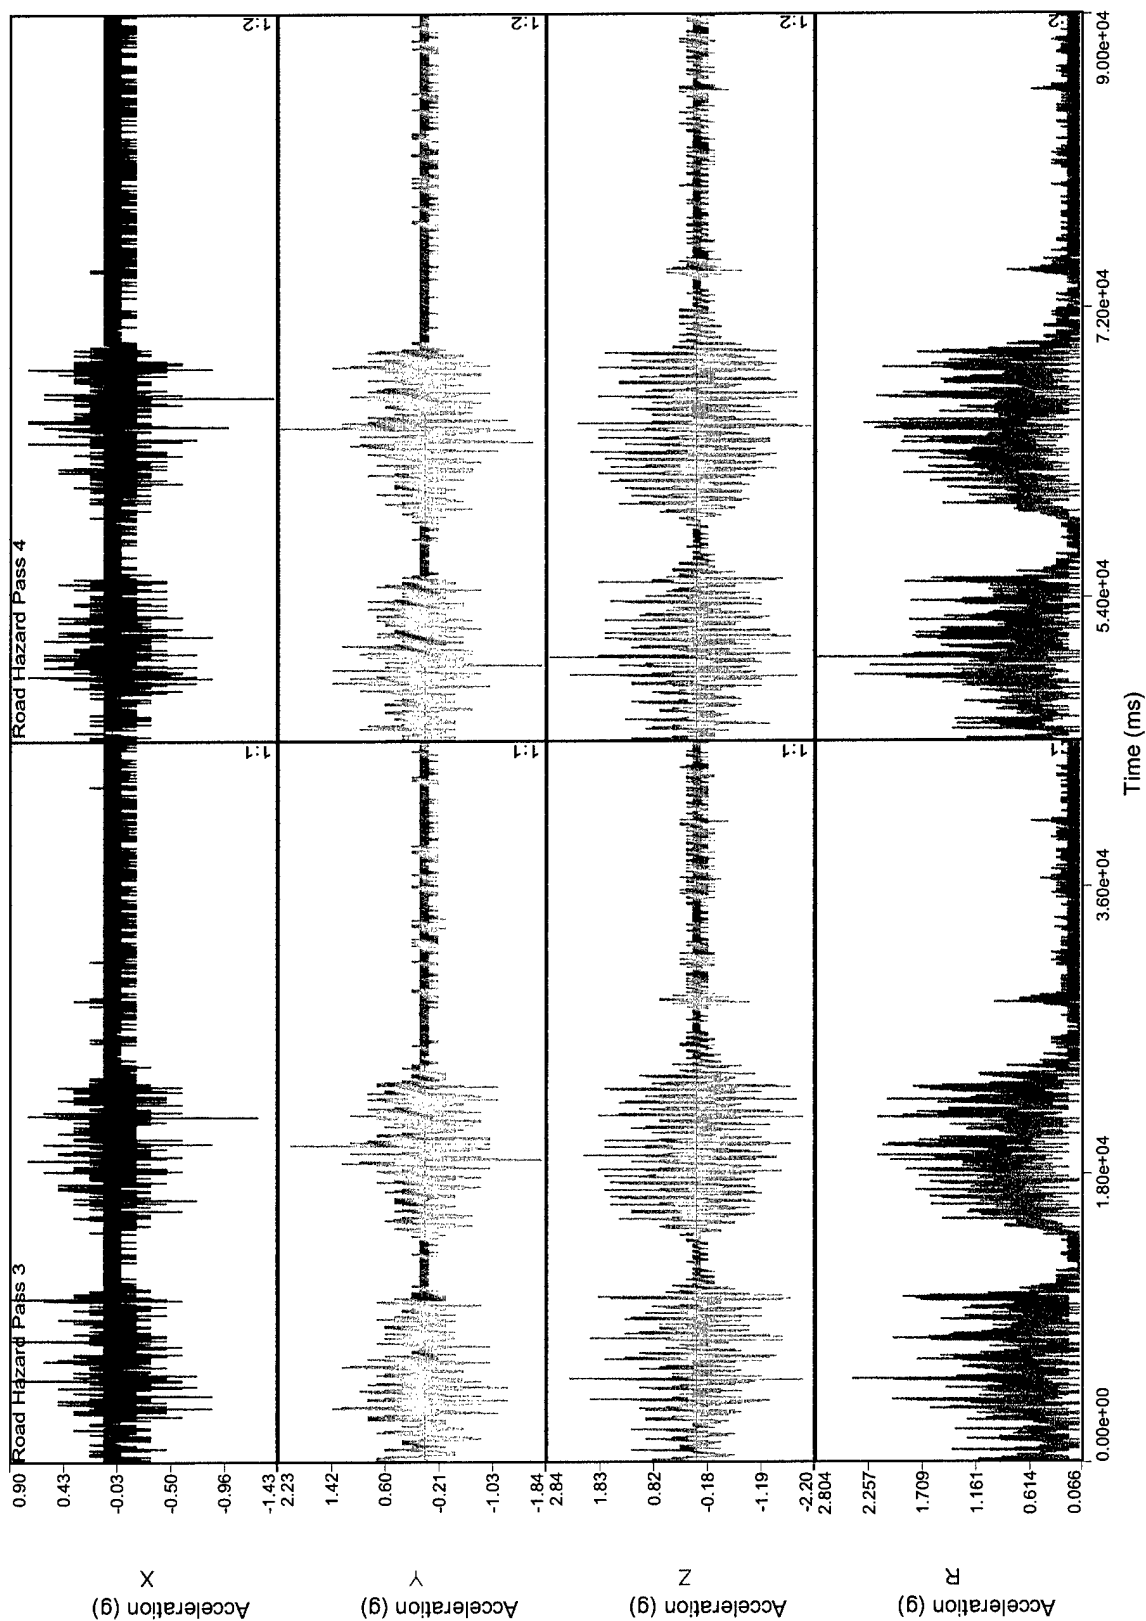
Hazard of M871A3 Trailer with 11,859-lb Payload      Sensor Location: Trailer Bulkhead

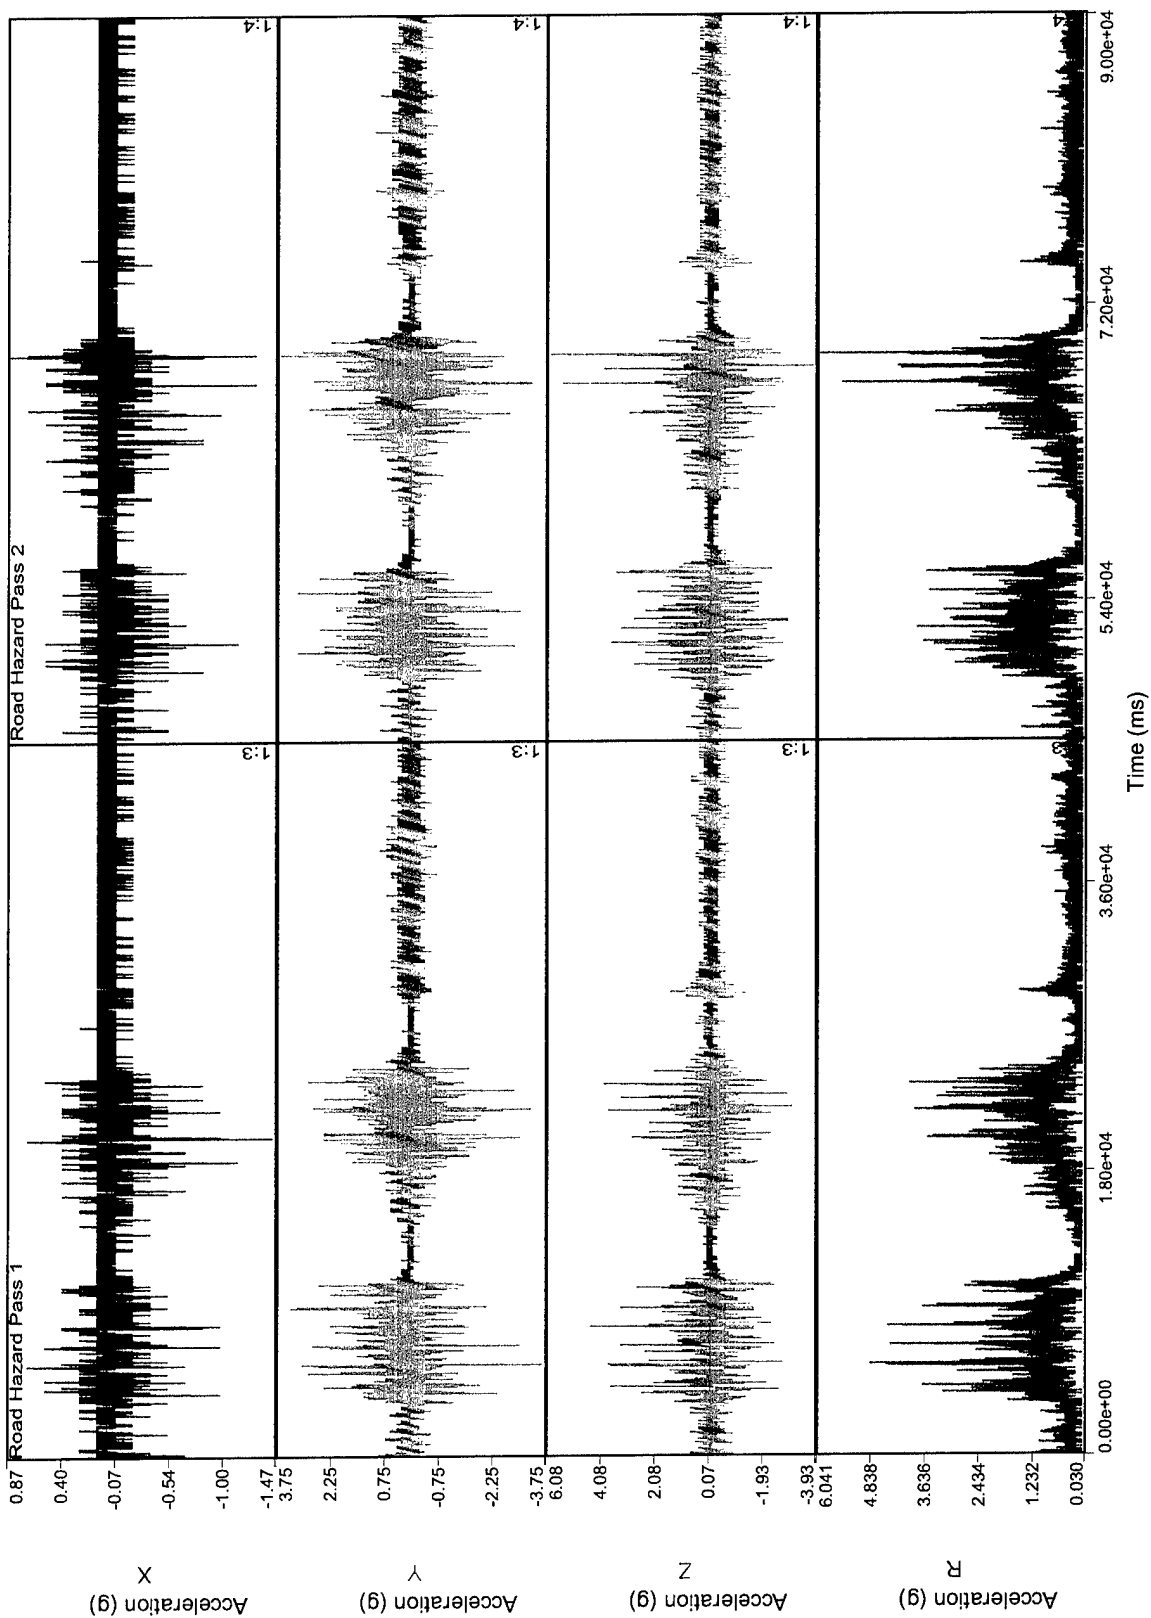
Hazard of M871A3 Trailer with 11,859-lb Payload      Sensor Location: Trailer Rear

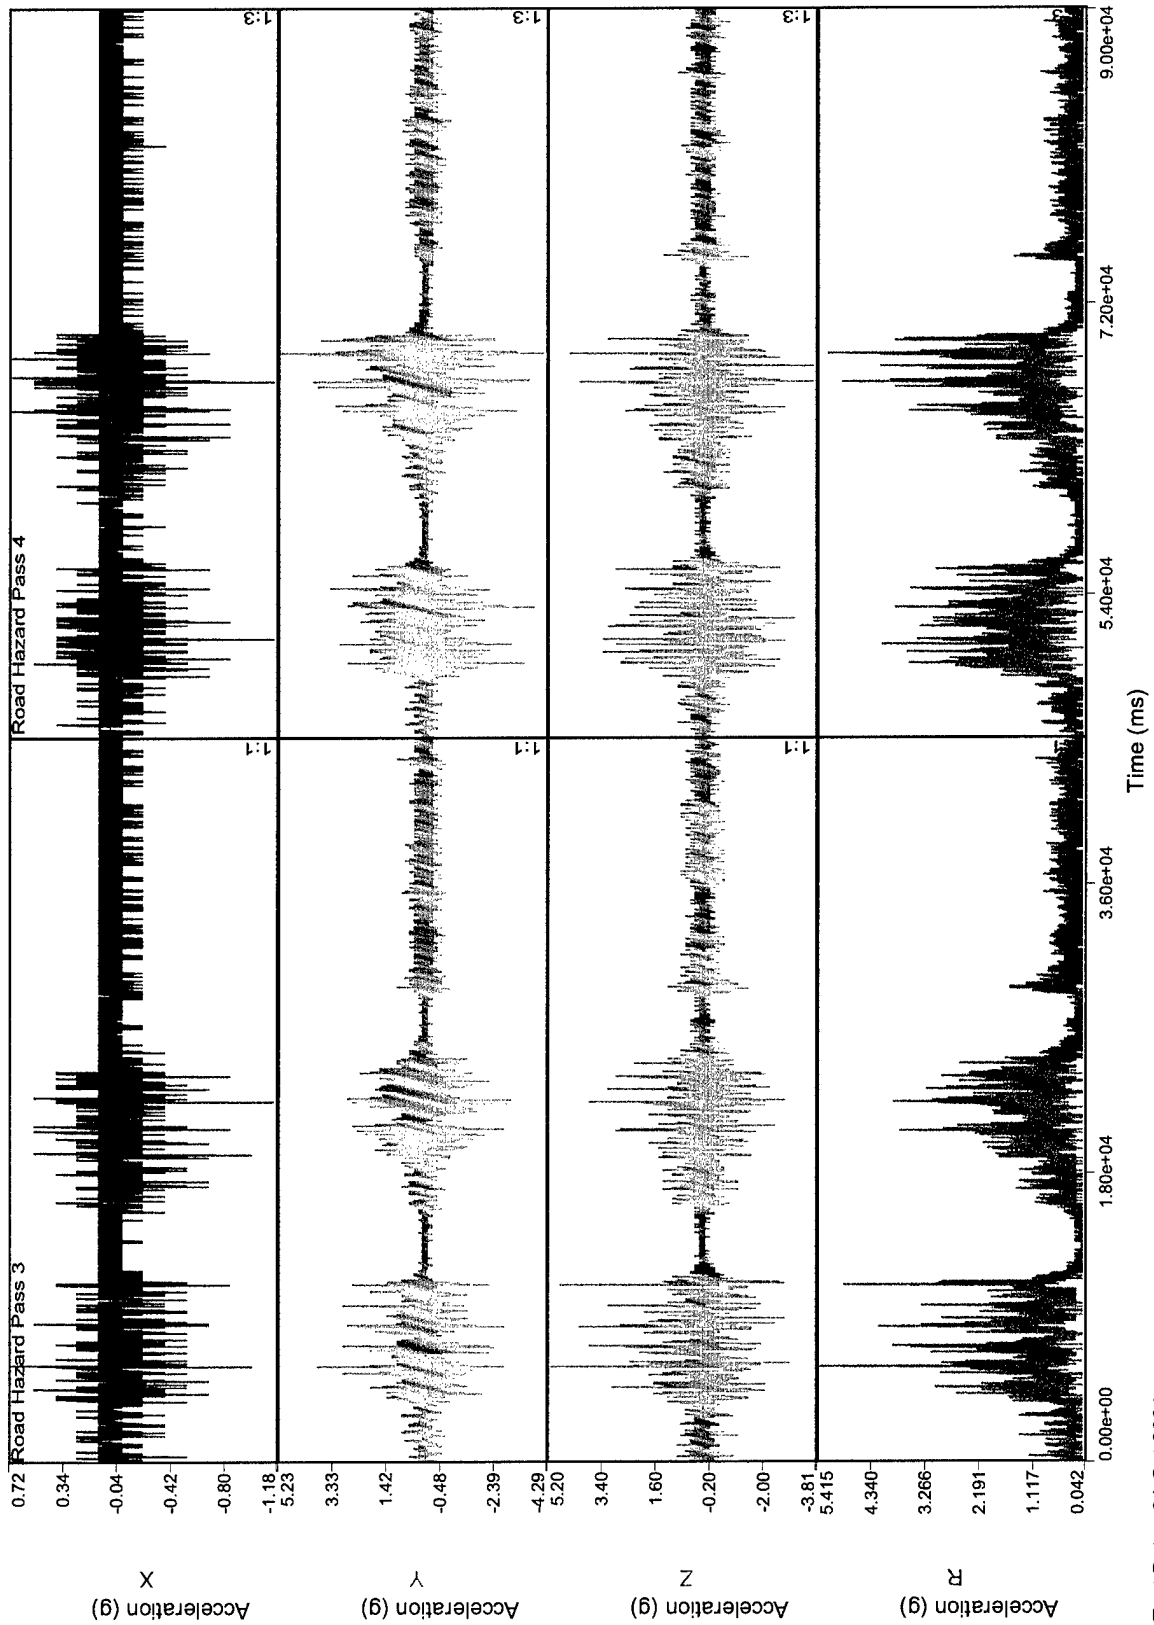
Hazard of M871A3 Trailer with 11,859-lb Payload      Sensor Location: Trailer Rear
